Zone d'entretien du TUF

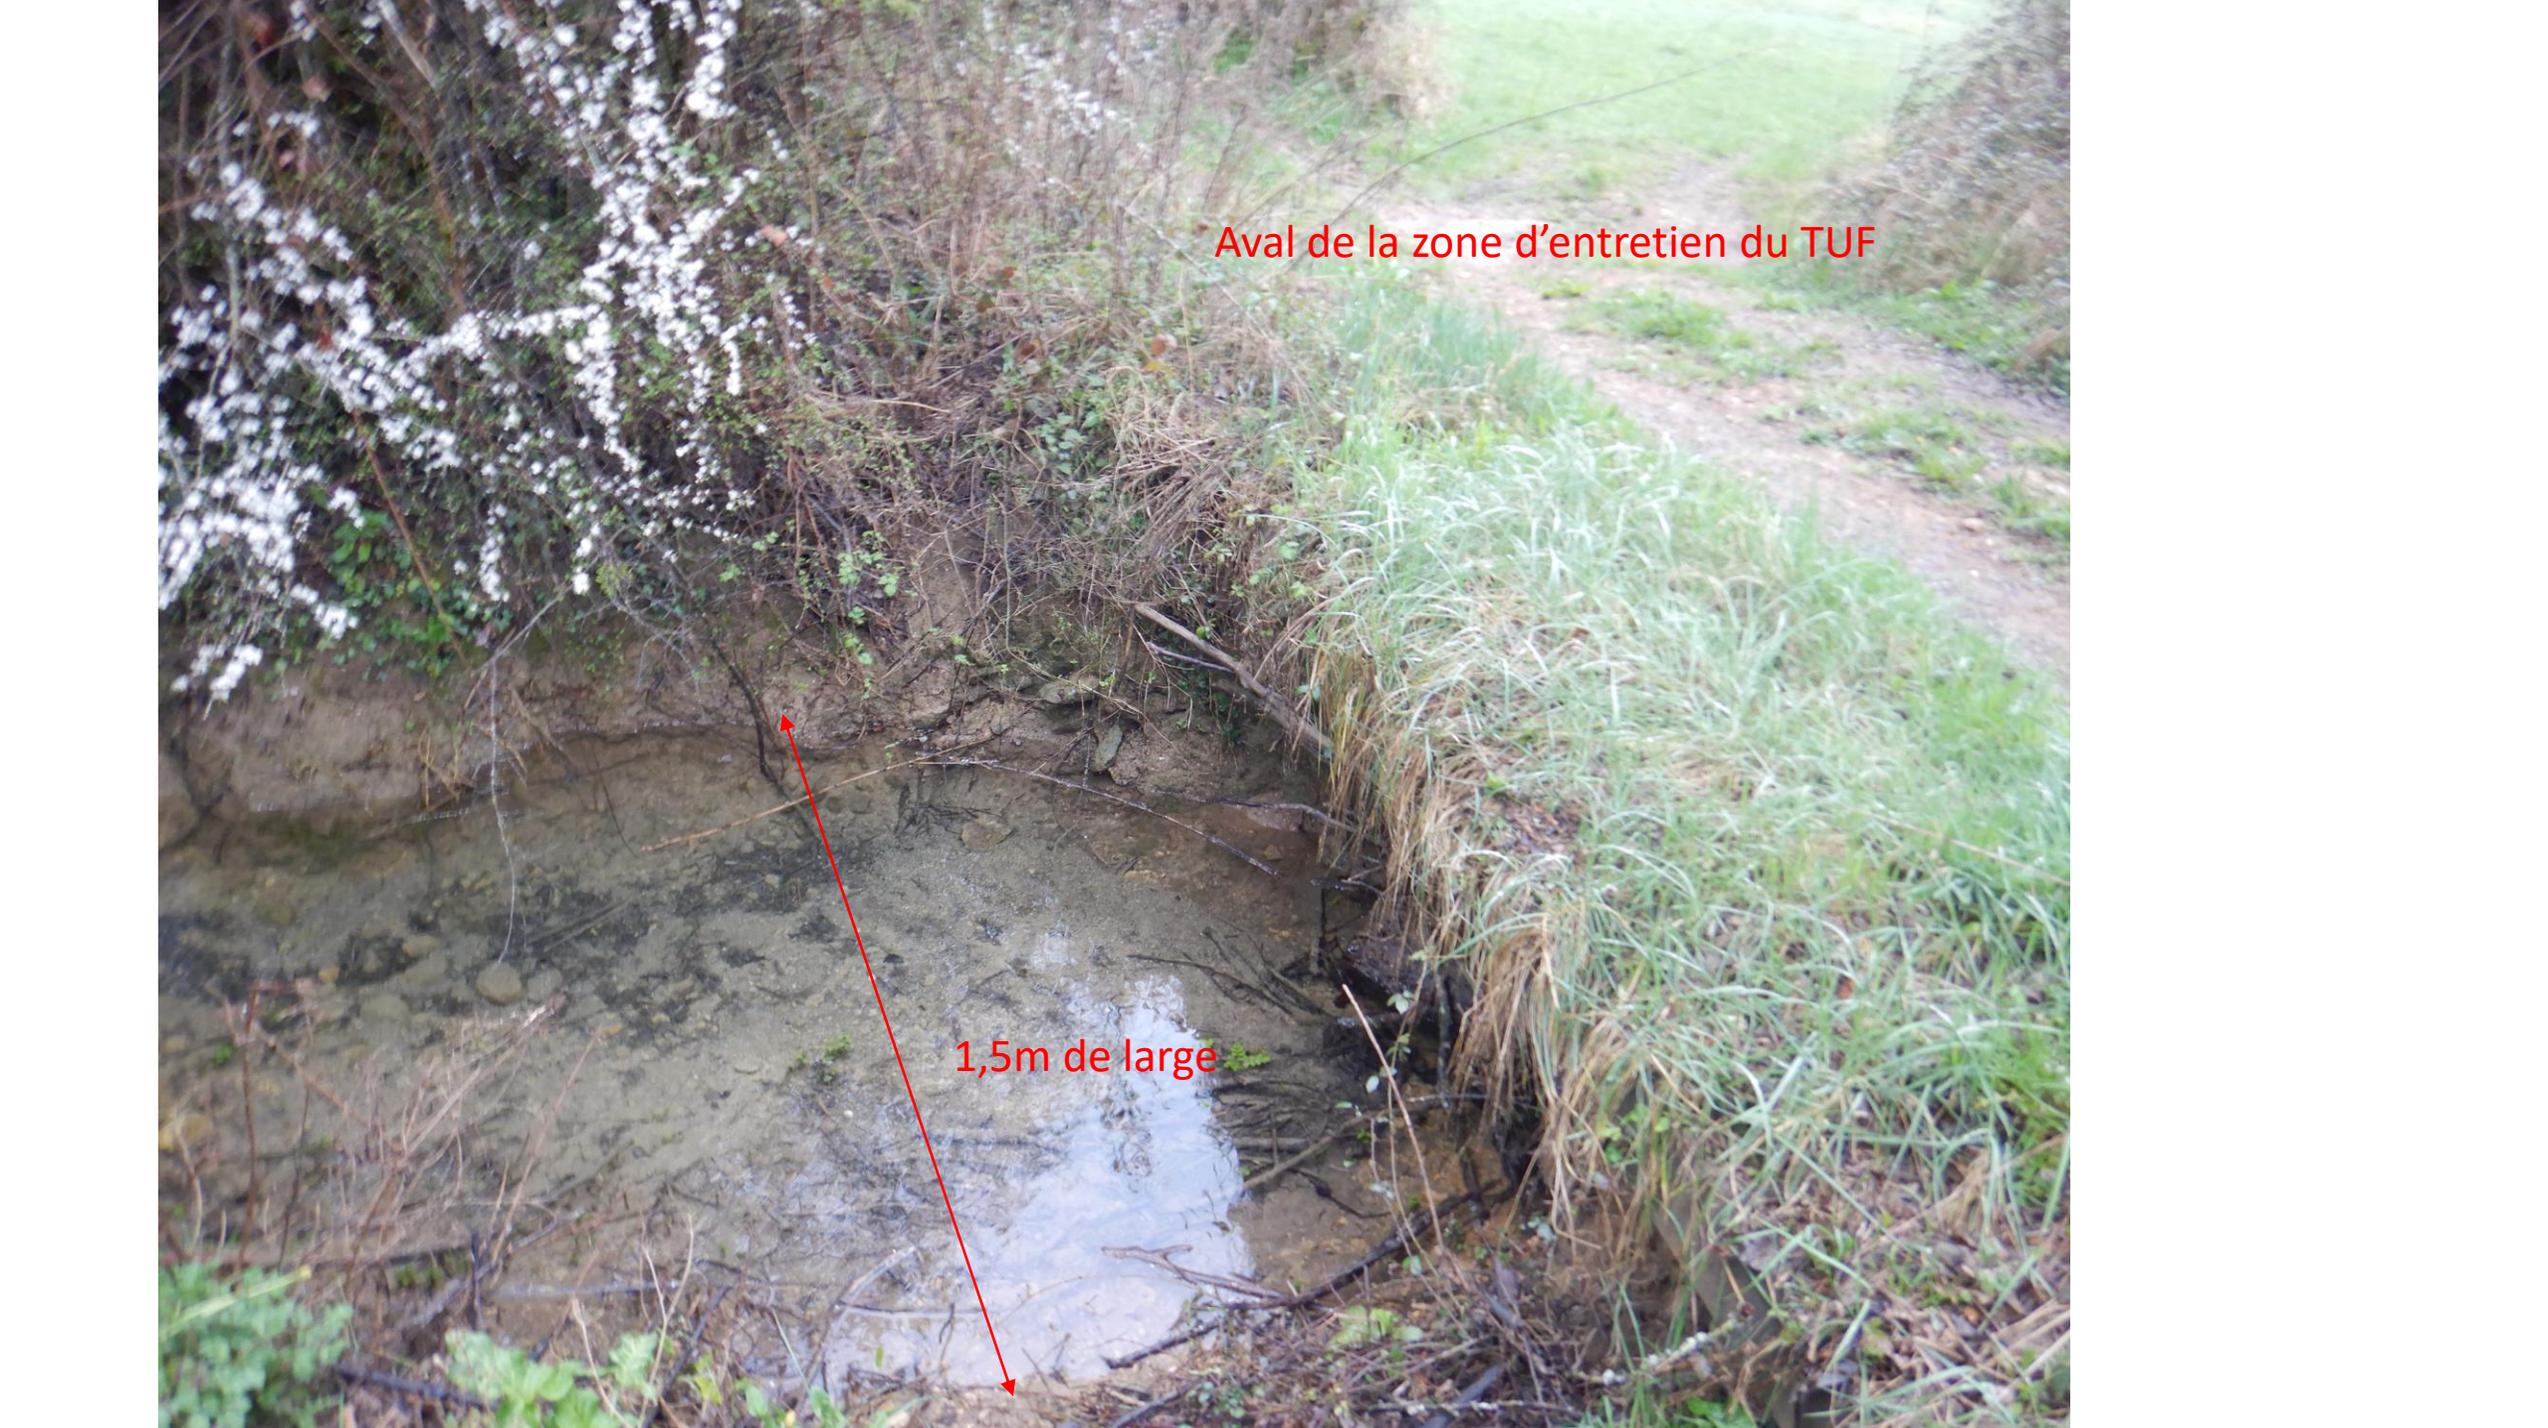
A photograph of a stream flowing through a natural, somewhat overgrown area. The water is clear and flows over a bed of rocks and sand. The banks are lined with various plants, including tall grasses on the right and dense, white-flowered shrubs on the left. A red arrow points from the text '1,5m de large' to a specific section of the stream. Another red arrow points from the text 'Aval de la zone d'entretien du TUF' to the same section of the stream.

Aval de la zone d'entretien du TUF

1,5m de large

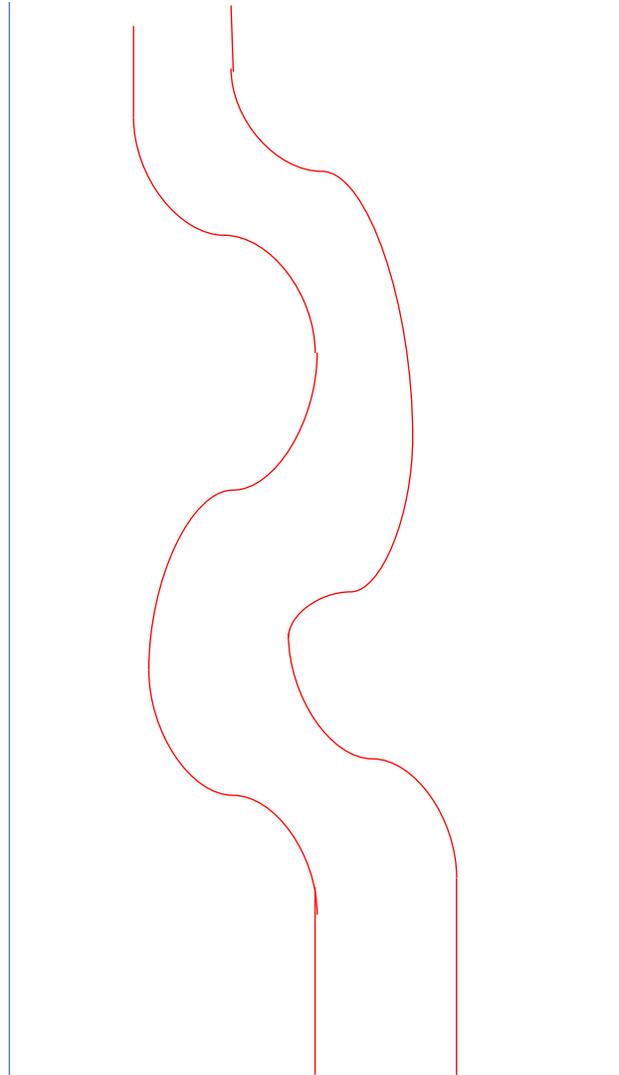
Lit avant travaux 4 m de large plein bord

Lit emboité après travaux 1 m de large, connexion amont aval
